Intel® Xeon® Processor 5500 Series

Specification Update

February 2015

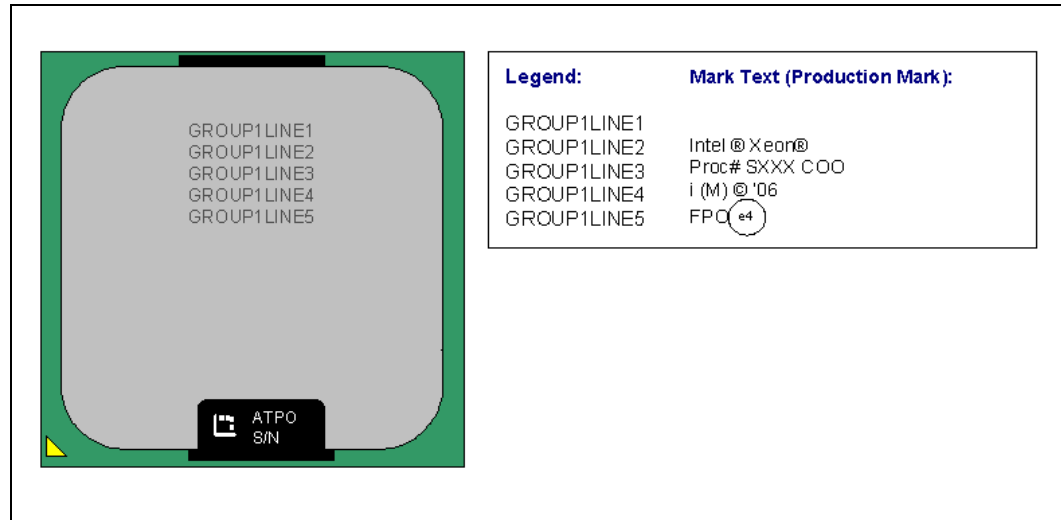
Intel® Xeon® Processor 5500 Series stepping can be identified by the following component markings:

Figure 1. Processor Top-side Markings (Example)
